## REINFORCED HYDROSEEDING

## HYDROMAT® H.A.B. – Hydraulically Applied Blanket

## HYDROMAT® H.A.B Hydraulically Applied Blanket

## THICK HYDROSEEDING

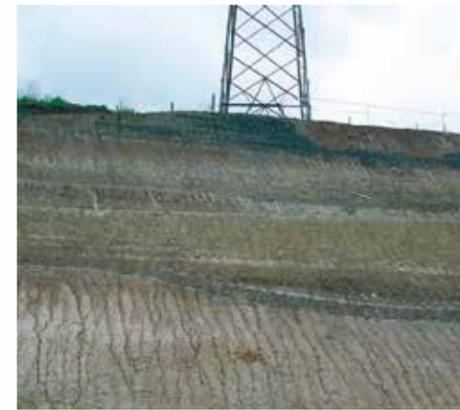
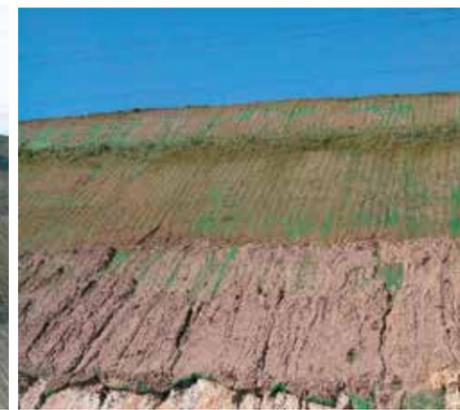
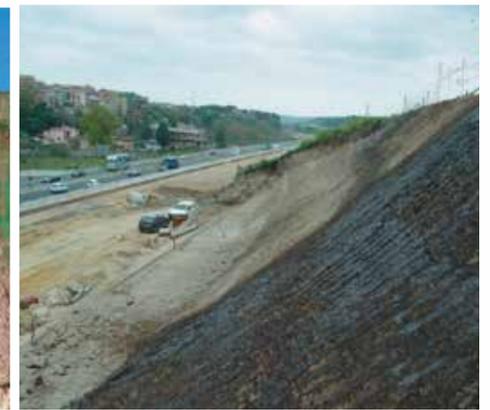
**PROBLEM:** The enlargement of the current Grande Raccordo Anulare roadway in Rome, at the trenched stretches, made it necessary to excavate and move back the existing slopes characterised by highly erodible tuffaceous materials of volcanic origin. The exposure of these slopes to the weather and to uncontrolled runoff of rainwater, due to the lack of vegetation, had resulted in the creation of deep erosion furrows which had developed all over on all slopes (photo 1). It is necessary to emphasise the poverty of the pedological substrate and the nevertheless steep slopes of around 45° - 50% (as shown in photo 3).

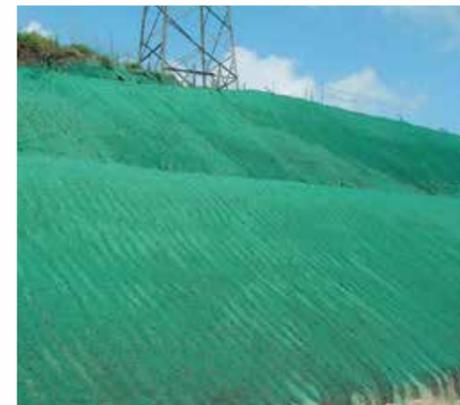
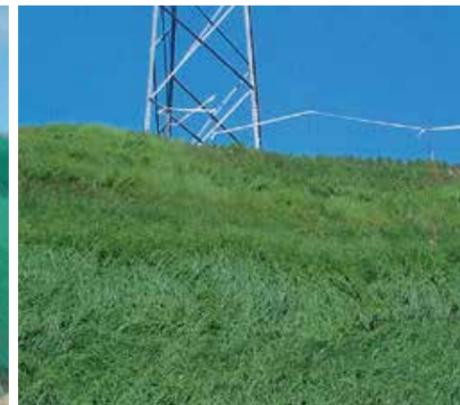
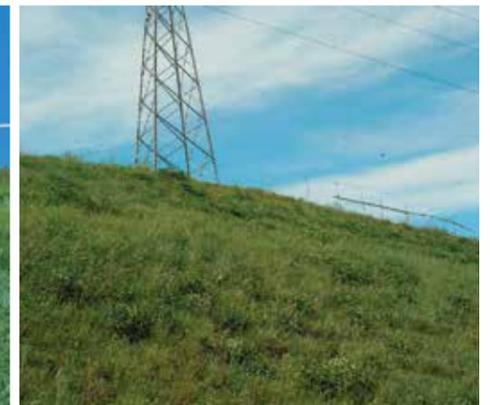
**FIRST SOLUTION ENVISAGED** This involved using a synthetic three-dimensional geomat, clogged with topsoil. The lack of complete adhesion between the geomat and the substrate meant that this attempt was ineffective, as is clearly shown in photo 2, causing multiple problems.

**FULL SERVICE SOLUTION:** the problem was solved by hydroseeding using a **Hydraulically Applied Blanket HYDROMAT®** performing application in 3 stages. The first two applications (photo 3) involved adding approximately 800-900 g/m<sup>2</sup> of organic matter to create a substrate essential to the vegetation, while the third stage involved covering with the H.A.B. and an organo-mineral fertiliser for a total quantity of approx. 600 g/m<sup>2</sup> (photo 4). For the coverage, given the great visibility of the work, in accordance with the clients and ANAS, it was agreed to use a green-coloured matrix.

The results obtained are evident and photo 5 highlights the enormous success (given the starting situation) after two months. Unlike the intervention with the geomat, the HYDROMAT® adhered completely to the slope, making it possible to saturate even the most hidden interstices formed with runoff. In this way, it was possible to create total protection at the side of the slope, allowing the seeds to germinate and, later, vegetation to consolidate permanently as we can see after a year in photo 6.

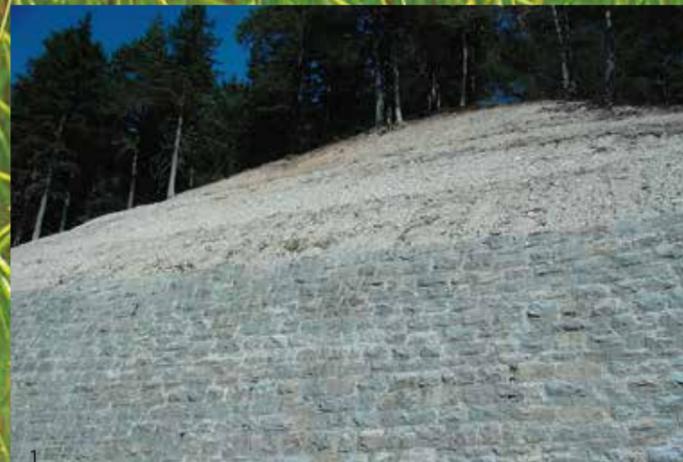
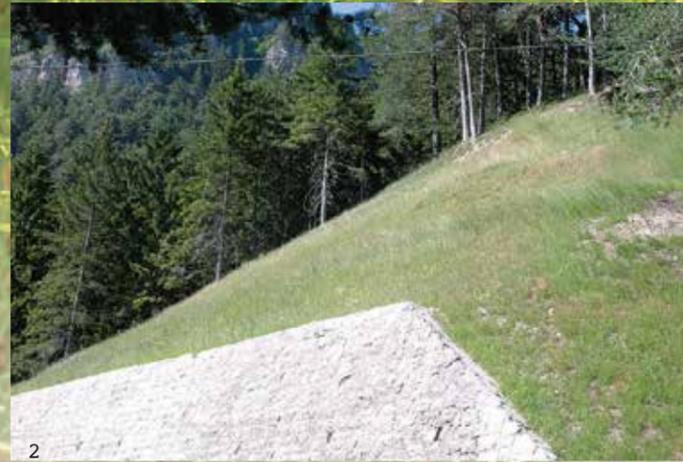
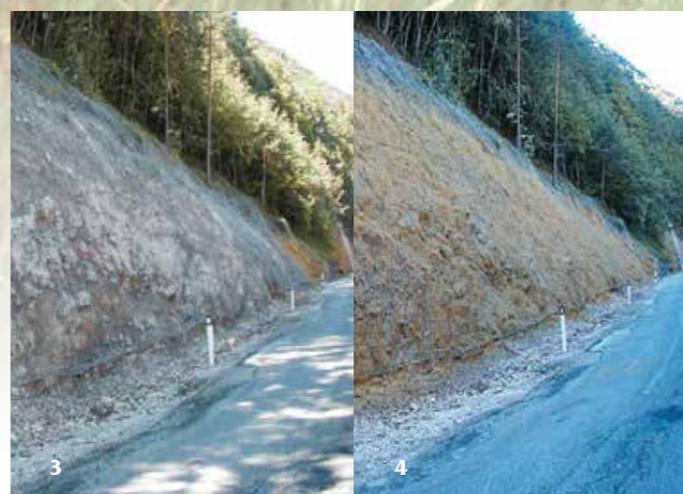
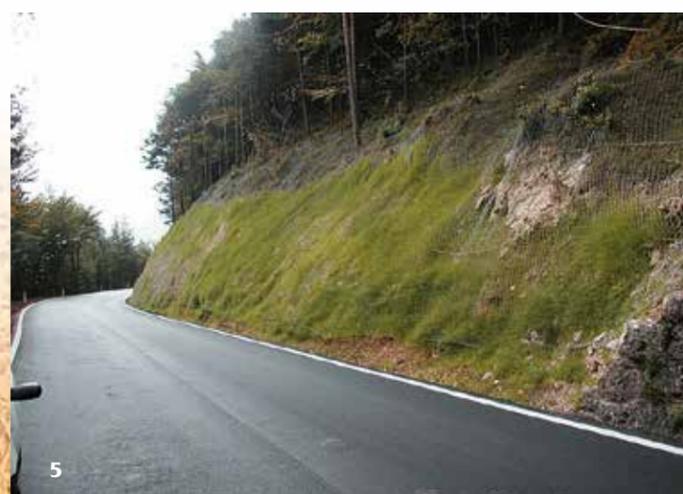
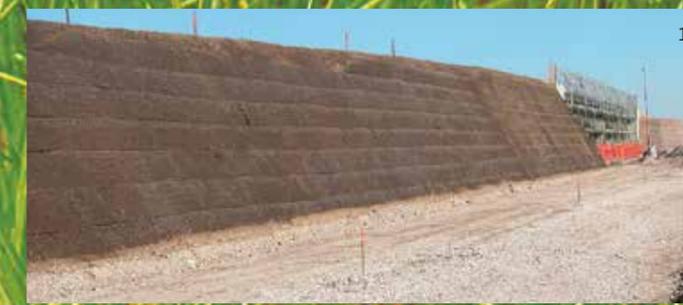
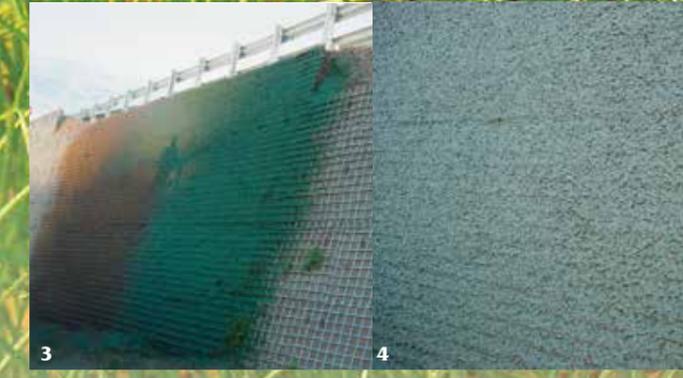
Here, the counterscarp slopes had a high gradient, over 50°, consisting exclusively poorly cemented granular soils (photo 1). The very poor structure of the soil made it logical to perform hydroseeding in two stages: the first aimed at enriching the substrate with nutrients and organic matter through a mixture of humus, seeds and fertiliser; the second adding a layer of **HYDROMAT®** (at least 400g/m<sup>2</sup>) in order to allow effective protection against the effects of rain and runoff water in the short and medium term.

The result is shown in photo 2, where we can see full recovery of the slope through vegetative growth. Note the absence of complete coverage, impossible to obtain in morphological and geological situations such as those described above, which nevertheless did not represent an inhibitory constraint to controlling the erosive dynamics towards vegetation.

For the partial recovery of greenery on the slopes, hydroseeding using the H.A.B. **HYDROMAT®** was carried out. The presence of a matrix of clay and silt between the discontinuities of the blocks of limestone, made it possible to intervene using this solution for re-greening.

Hydroseeding was carried out in two stages: the first aimed exclusively at enriching with organic material and fertiliser mixed with seeds and adhesive to create a suitable substrate. The second seeing the application of **HYDROMAT®** mixed with a further quantity of fertiliser for final hydroseeding fixing. The result can be seen in photo 5 where, as expected, the re-greening is only partial. The effects of hydroseeding are also highlighted by the absence of rocky debris at the base of the slope, as well as the fact that the slope appears considerably different.

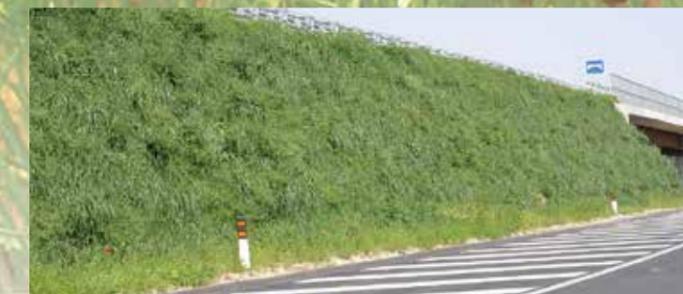
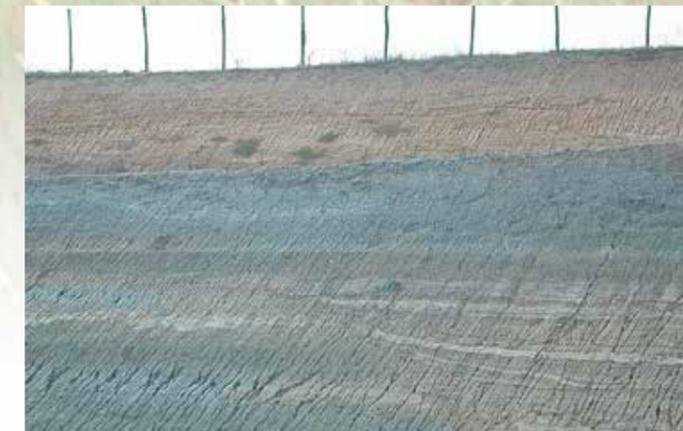
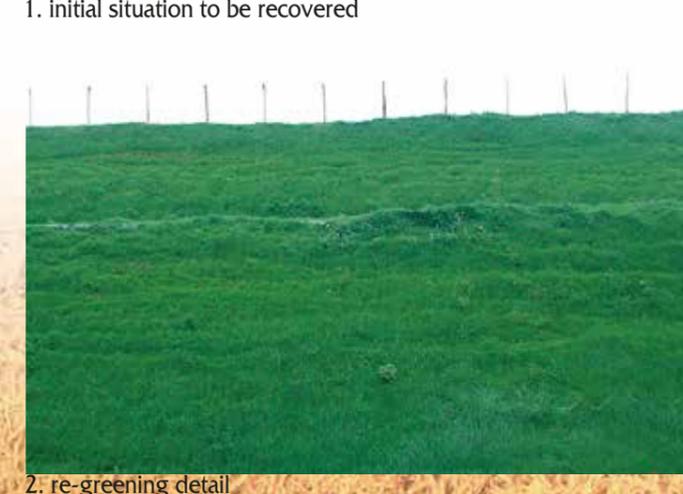
It is important to stress the complementarity of the two stabilisation interventions carried out, which saw the presence of mesh and cables for passive defence and hydroseeding with **HYDROMAT®** or re-greening and the consolidation of the fine matrix between the discontinuities.
